# Roadranger Warranty Repair Guideline RWRG0069

## RWRG0069 - Fault Code 64 on Generation 1 Electronic Clutch Actuator (ECA)

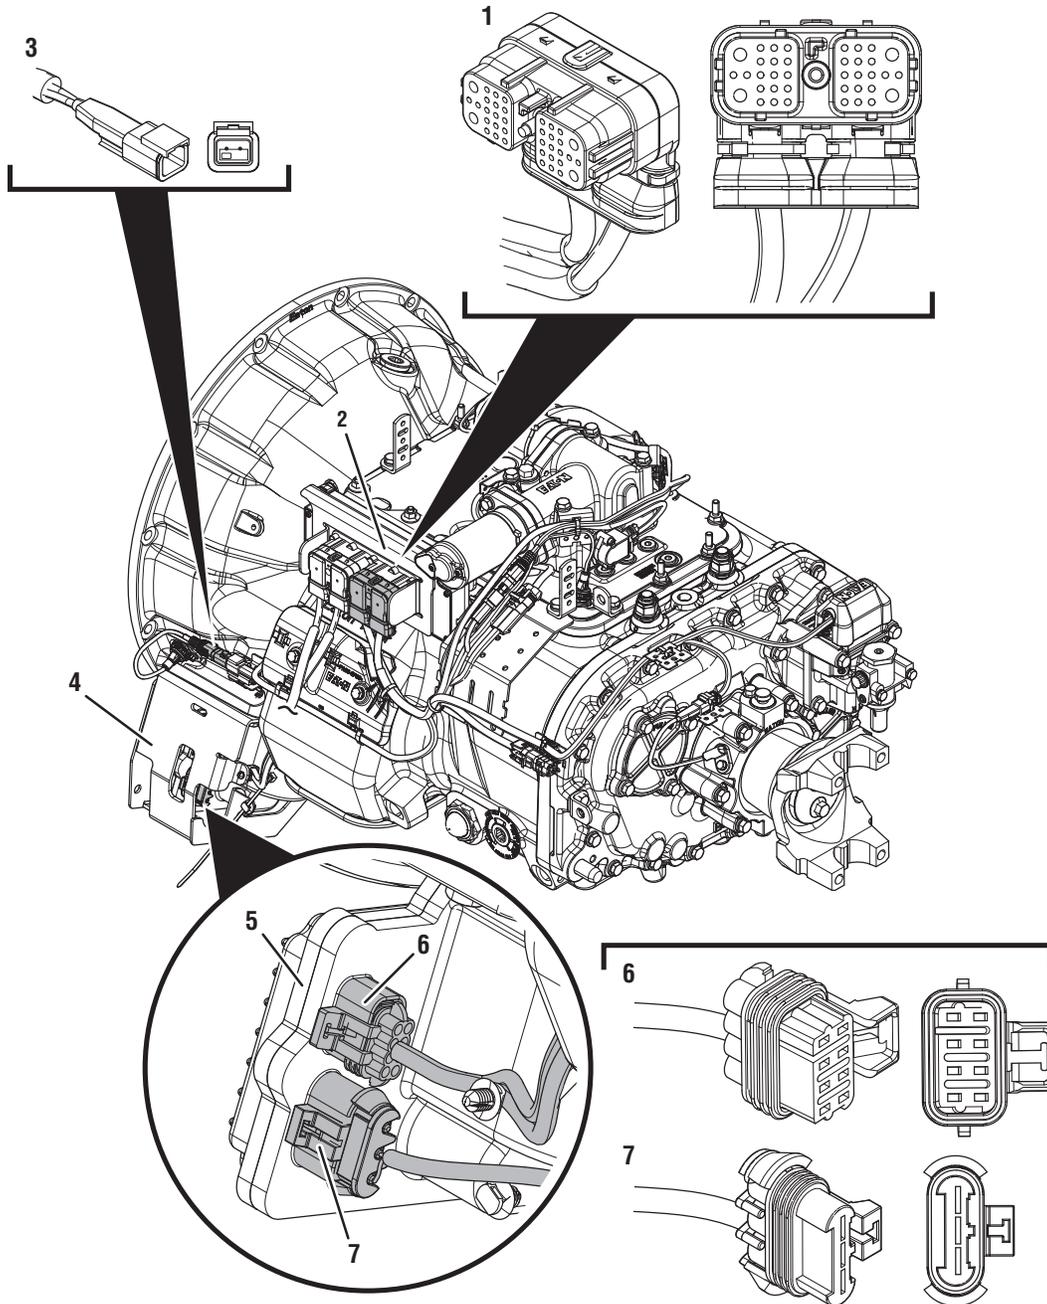
- 1. 38-Way Vehicle Harness Connector
- 2. Transmission Electronic Control Unit (TECU)
- 3. ECA Shield
- 4. Electronic Clutch Actuator (ECA)
- 5. 8-Way ECA Connector
- 6. 3-Way ECA Power Supply Connector

The UltraShift PLUS transmission is equipped with an Electronic Clutch Actuator (ECA) that controls the position of the clutch assembly. Power and ground to the ECA are OEM-supplied through a 3-Way Connector directly connected to the vehicle batteries. The ECA is connected to the Transmission Electronic Control Unit (TECU) by an 8-Way Connector that is part of the transmission harness. The ECA communicates with the TECU over the High Integrity Link (HIL) to change position, show faults or include other operation information.

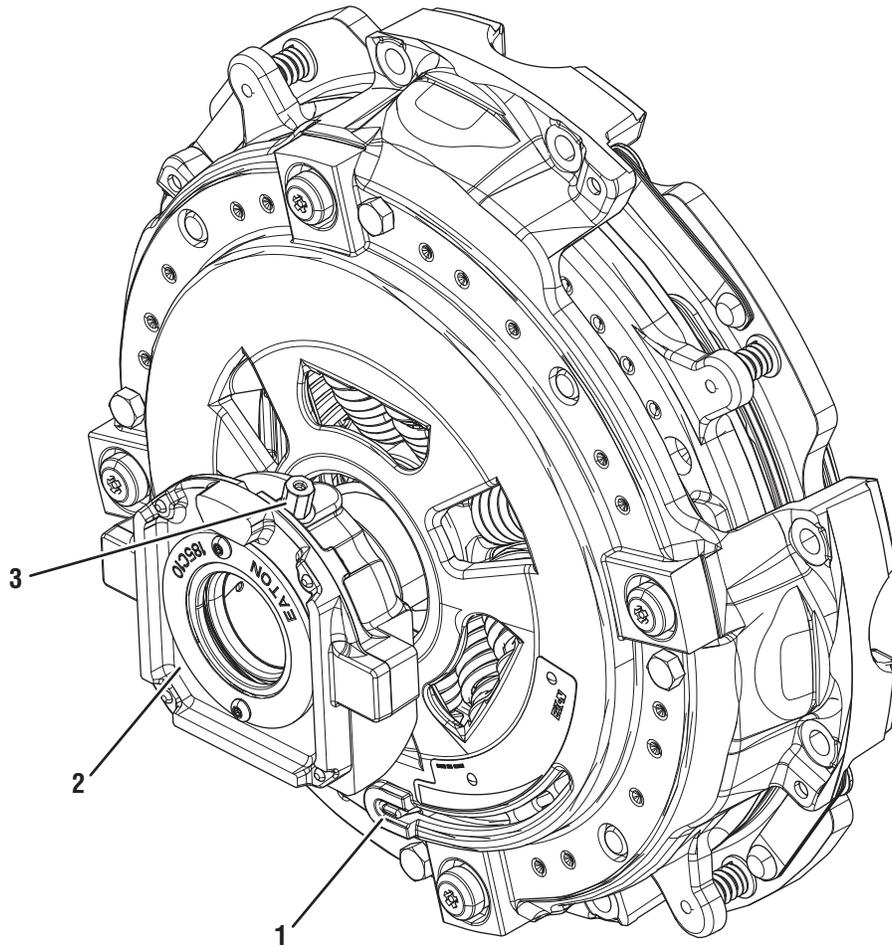
*Eaton ECA Clutch*

*1. Clutch Wear Tab*

*2. Release Bearing*

*3. Release Bearing Grease Zerk*
