RWRG0078 - Fault Code 63 Pre-Authorization

Overview

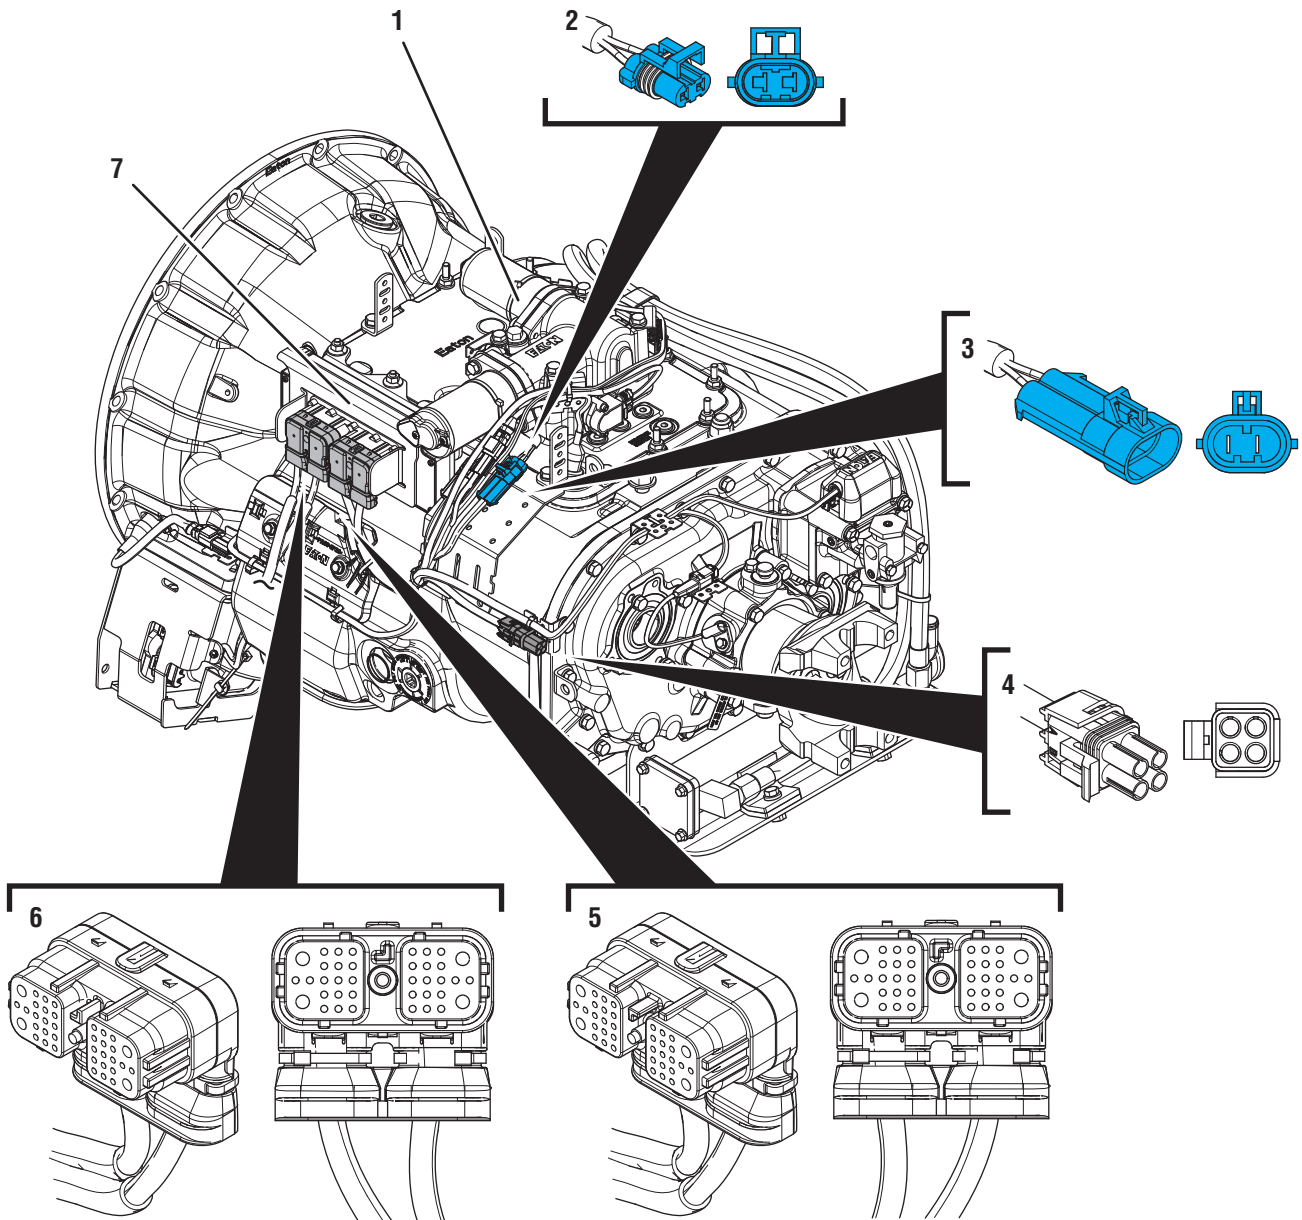
Component Identification

- 1. X-Y Shifter
- 2. 2-Way Gear Motor Connector (blue)
- 3. 2-Way Gear Motor Connector Body (blue)
- 4. 4-Way Diagnostic Connector
- 5. 38-Way Transmission Harness Connector
- 6. 38-Way Vehicle Harness Connector
- 7. Transmission Electronic Control Unit (TECU)

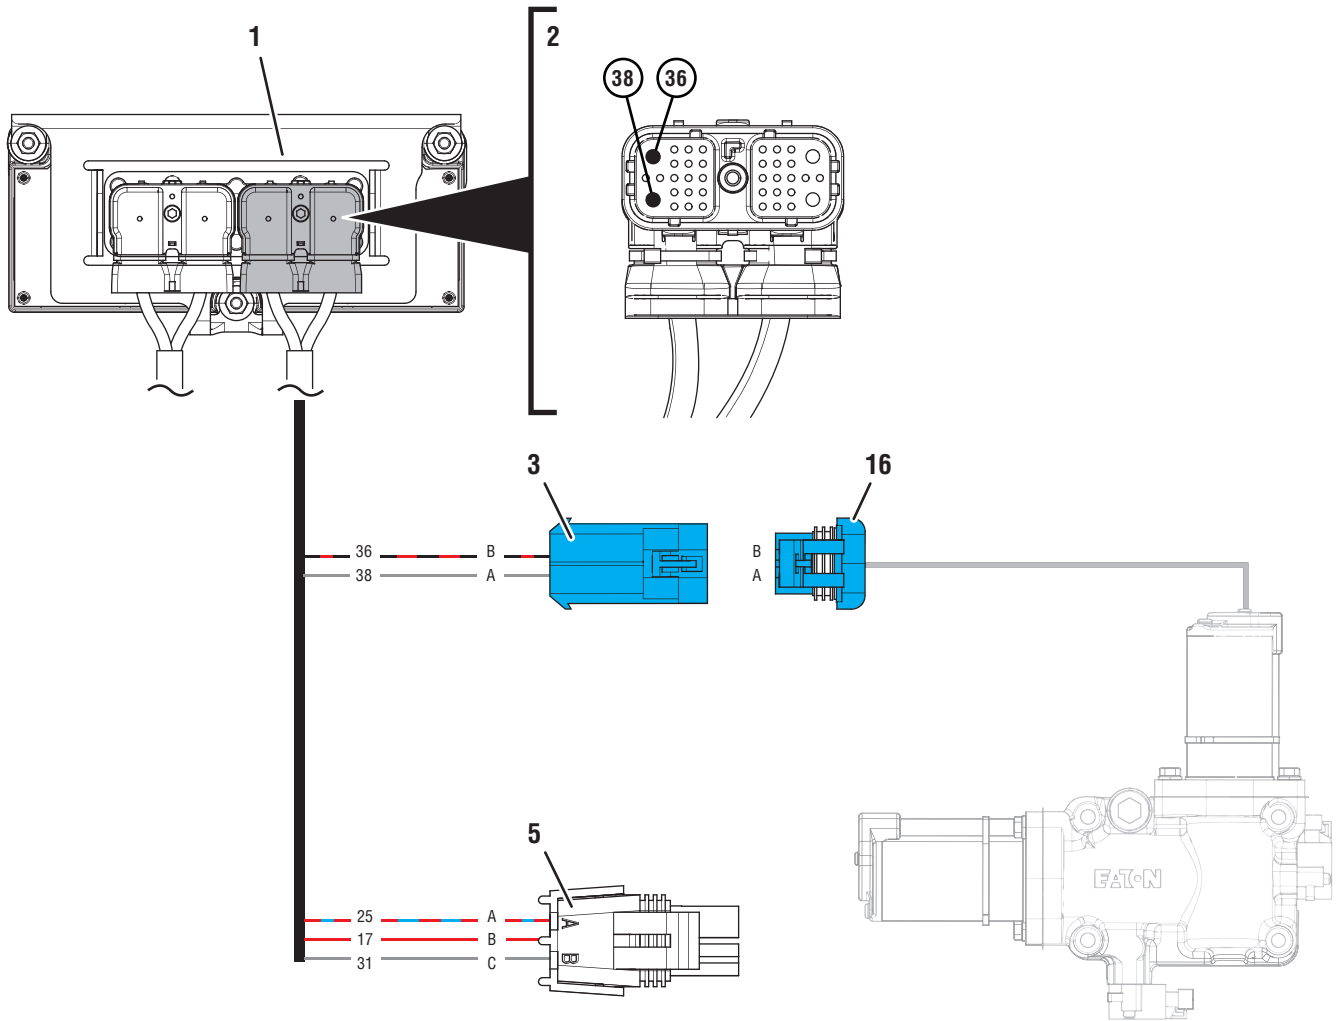
- 1. Transmission Electronic Control Unit (TECU)
- 2. 38-Way Transmission Harness Connector
- 3. 2-Way Gear Motor Connector Body (blue)
- 4. 2-Way Gear Motor Connector (blue)
- 5. 4-Way Diagnostic Connector

■ Battery Voltage	■ Switched Battery from TECU	■ Ground	■ Communication	■ Signal
■ Ignition Voltage	■ Switched 5V from TECU	■ Switched Ground	■ Relay/Solenoid Driver
