Rebuilding The 6.6L Duramax Diesel

By Roy Berndt

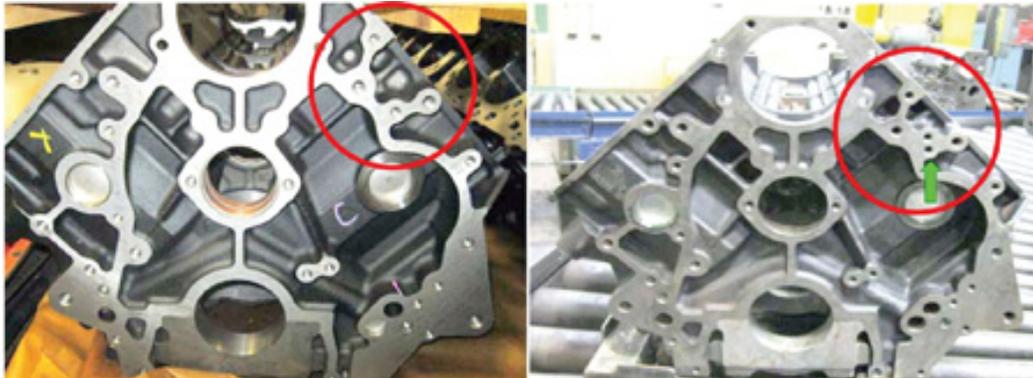
Figure 1. The block on left is 2001-'05 MY production and the block on the right is '06 MY and up production. Note the additional bolt holes for the later, higher-output water pump.

The first block casting was used from the original release through the end of 2005 MY of production. It is easily identified by the difference where the water pump bolts to the block and the bolt bosses (or absence thereof). See **Figure 1**.

The second block has the additional bosses and also uses longer main bearing bolts. The main bearing bolt used in '05 MY and earlier is approximately 4- $\frac{1}{4}$ " long. The bolts used in '06 MY and later are approximately 4- $\frac{1}{2}$ " long.

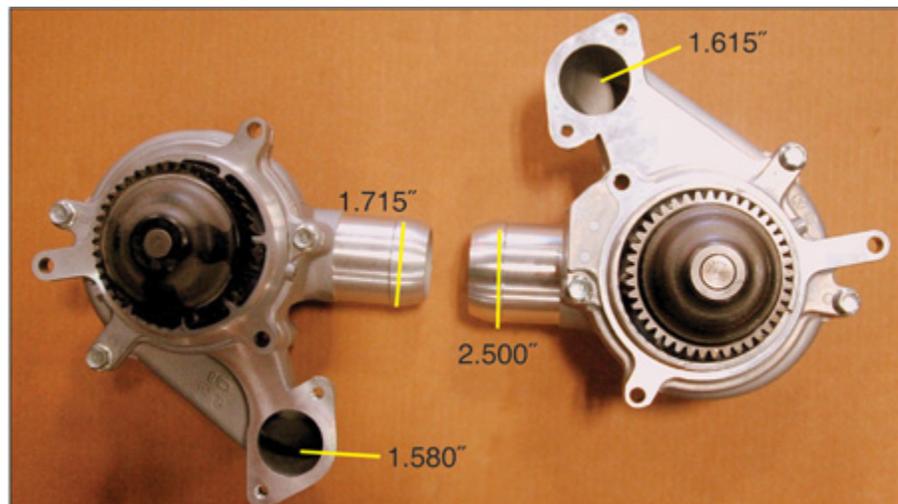
Figure 2. Water pump on the left is used through '05 MY and has a smaller water outlet size. The water pump on the right is for '06 MY and up with a higher volume and flow that eliminated the potential for any overheating and has a larger outlet size.

The water pump mounting bolts changed but so did the water pump. There is a larger output and higher volume water pump being used (see **Figure 2**) as seen by the difference of the output outlet.

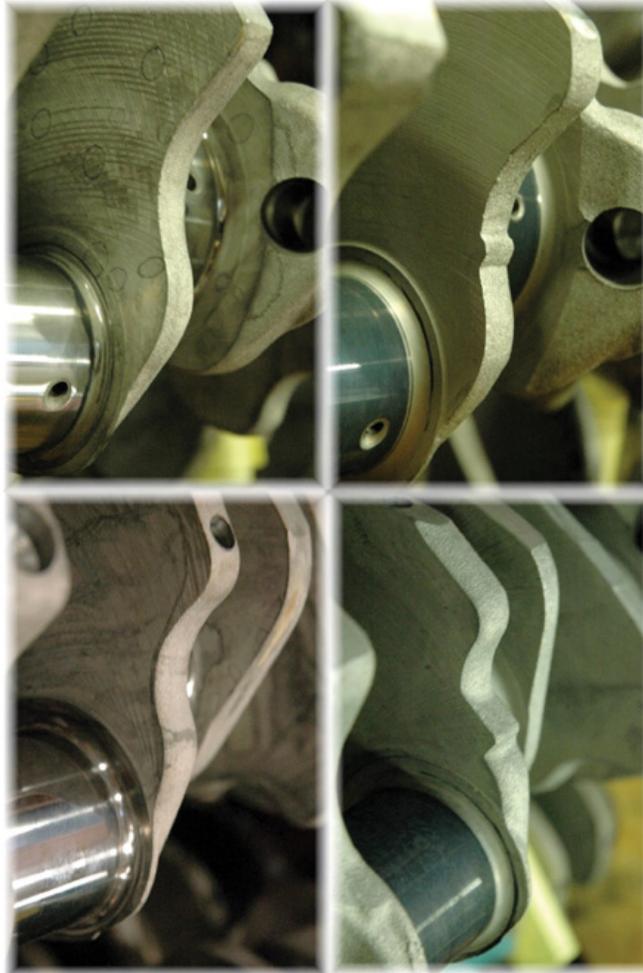
Figure 3. Upper and lower views on the left is the early crankshaft through '05 MY. The views on the right that have the small “bumps” in the forging are of the '06 MY to current production crankshaft. These crankshafts are balanced differently and are reported to be not interchangeable.

There are two crankshafts for the D-Max up through '05 MY and '06 MY and later. There is a difference in their balance and their differences are very subtle. There are a couple of “bumps” in the forging in the area just off the second and fourth main bearing journal area (see **Figure 3**) for the '06 MY and later parts, but dimensionally the two cranks are identical.

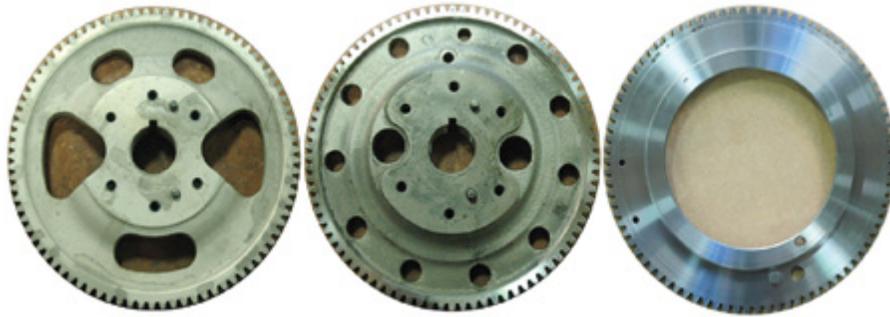
Figure 4. Camshaft timing gear on the left is early solid style thru '05 MY and on right the two pieces that are used as the spring loaded assembly to avoid and eliminate potential timing noise '06 MY to current.

Camshafts are easy to identify: they are all the same, except for the timing gears. As shown in **Figure 4**, the early timing gears (through '05 MY) were solid and '06 MY and later used a split gear that is spring loaded to avoid any type timing gear train noise. These camshafts are rifle

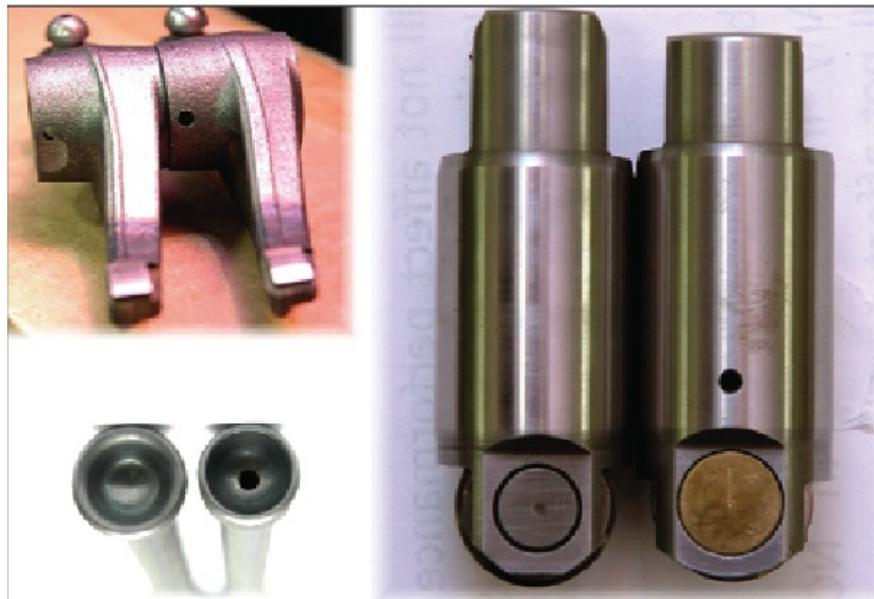
Figure 5. The upper left has the '05 MY on the left and '06 MY on right – note the difference in oil hole size. Pushrods on the lower left are '05 MY and earlier on the left and '06 MY and later on the right. Lastly, on the right side of the picture, the cam follower on the left is through '05 MY and '06 MY to current is on the right.

The same '05 MY and '06 MY break for changes applies to the rocker arms, cam followers and pushrods. Through '05 MY the pushrods were solid and did not have oil running through them. Beginning in '06 MY the push rods were hollow and did have oil running through them. Rocker arm oiling holes changed from .110" to .150". The cam followers changed to a larger diameter pin that the roller would rotate on as it followed the cam lobe. This lifter also had provisions to feed oil through the pushrod (see **Figure 5**).

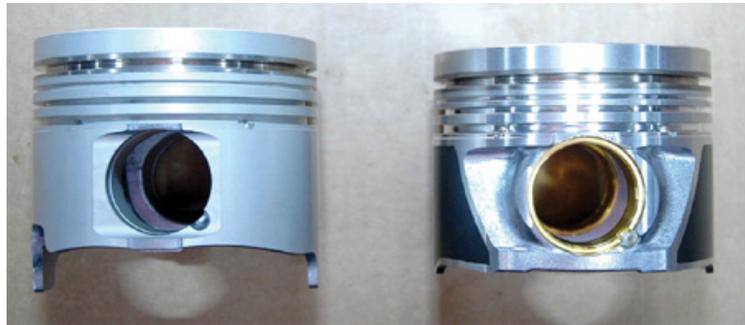
Figure 6. The piston on left was used up through the '05 MY and the piston on right is '06 MY and later with a longer wrist pin.

The pistons follow suit with the rods. The different model years obviously had a pin length change and they have different compression ratios. Visually, they are unmistakable (as seen in **Figure 6**). The later piston is scalloped and had bushings for the wrist pin, and has a graphite coating on the skirt.

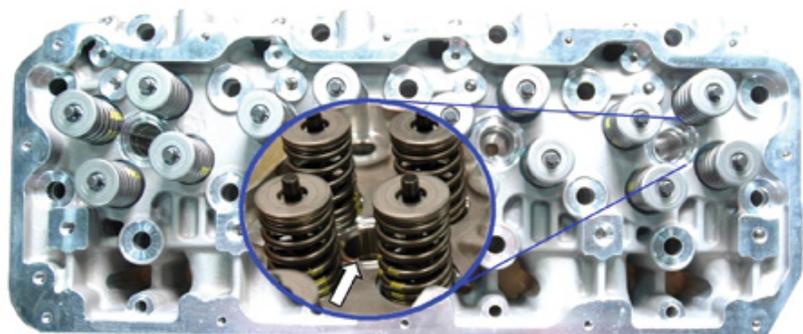
Figure 7. The early cylinder head through mid '04 MY had injectors under the valve cover and the injector sealed deep in the head as seen in the inset with arrow.

The first cylinder head was used through mid-'04 MY and had the injectors under the valve cover. The problem was, if an injector went bad it contaminated the lubricating oil and often the result would be a catastrophic engine failure. This cylinder head is easily identified by the valve cover rail being around the perimeter of the cylinder head (see **Figure 7**) and the fact that the injectors sit way down in the cylinder head between the four valves.

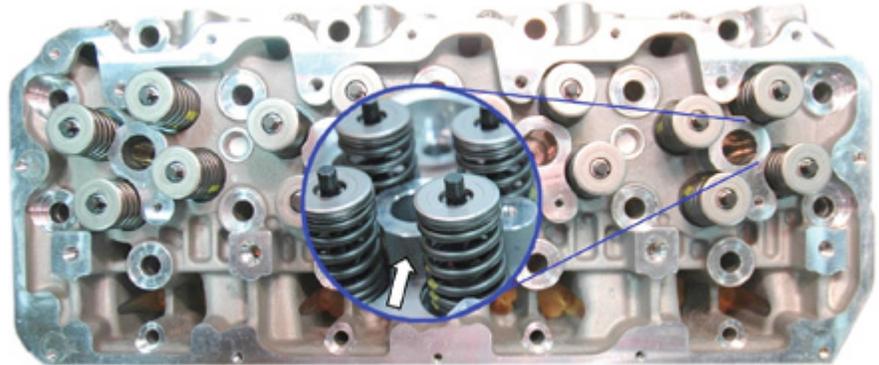
Figure 8. The second design head mid '04 MY through '05 MY with injectors out of the lubricating oil mounted on a raised boss (see inset) allow for a rapid identification.

The second cylinder head, which came into being mid-'04 MY, had the revised valve cover and the new injector that was now outside of the lubricating oil (see **Figure 8**). This model head is easily recognized not only by the cover but the injector is longer and the mounting surface is a raised boss that you cannot mistake.

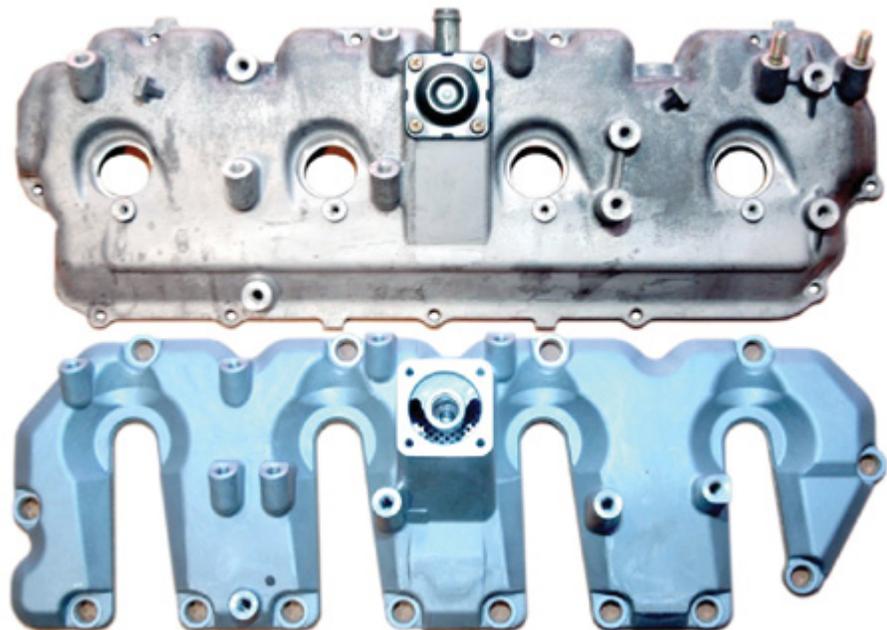
Figure 9. The valve cover on the top is the early cover through mid-year '04 MY. The lower cover is redesigned so that injectors are outside of the lubricating oil and they are the later type cover used through current production.

There have been two basic Duramax valve covers used, if you discount the crankcase ventilation differences (see **Figure 9**). A larger, normal looking cover that had the injectors underneath was used through mid-'04 MY. The second looks like a pretzel project gone bad. Injectors are out of the cover with no chance of contaminating the lubricating oil. This second cover also went through various renditions of emissions experimentation, with the orifice sizes for the crankcase ventilation changing from .370" to .465" to, lastly, .560". If you replace a cover, know which hole you have for crankcase ventilation.

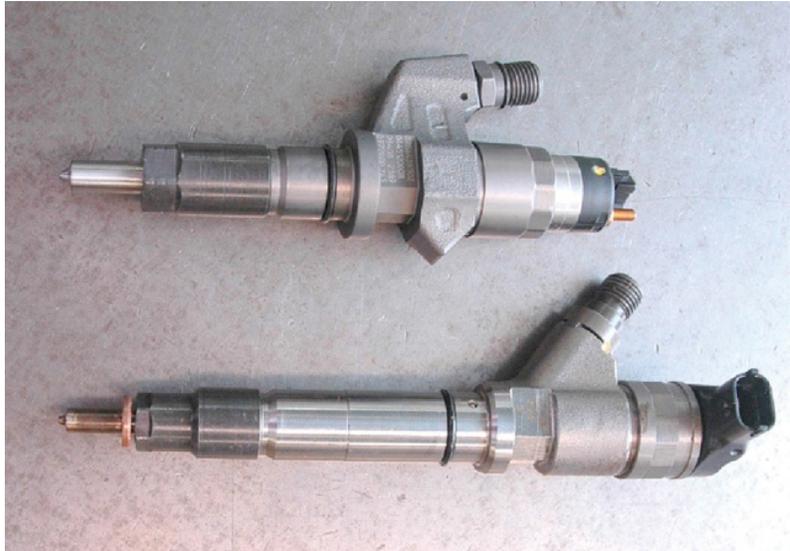
Figure 10. The injector on top is the one that was used under the valve cover and inside the engine oiling system. Mid '04 MY the cylinder head and valve cover were changed to have the fuel injectors outside the lubricating oil eliminating any chance of fuel dilution of the oil.

The Duramax had two different fuel injector body types. The one that sat under the valve cover is shorter and in the lubricating oil. The injector that now sits outside the valve cover is quite a bit longer and there is no way to mix them up or put one in the wrong head (see **Figure 10**) for proper identification).

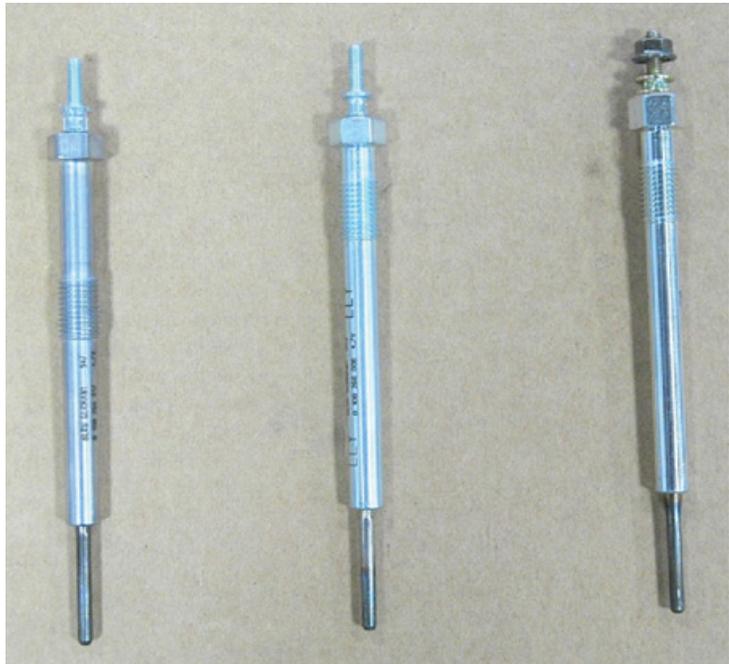
Figure 11. The glow plug on the left is for the early production injector under cover cylinder head. The center one came on the scene in mid '04 MY and is used through '05 MY and the last one on the right is '06 MY through current production. They are all different and do not interchange.

Three different glow plugs were used to correspond with the three different cylinder heads (see **Figure 11**). The first and second series glow plugs (used in the mid-'04 MY through '05 MY engines) look identical but have different voltages. The early production is 11 volt and the mid-'04 MY is 4.7 volt. The barrels have the voltage marked on them so do not inter-mix these glow plugs or there will be problems. Either the engine will not start or you will be burning up your glow plugs. The '04 MY injector and the '06 and later glow plugs are actually the same glow plug but the '06 MY has the threads about midway down the body. As stated earlier, the glow plug hole is the major difference between the two cylinder heads.
